Infrared inspections of electric substations: the importance of developing a Plan

James Dan Roark, Knoxville Utilities Board (KUB), Knoxville, Tennessee

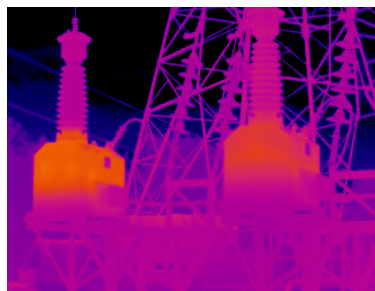
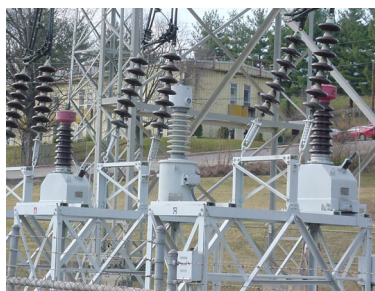
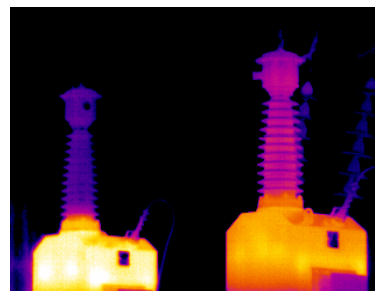
Figures 1a-1c: 69KV Potential Transformers. Empty Bushing on Left

Be very careful with camera settings. Figures 1a and 1c show the same image. If slight thermal variations are present and go undetected, extremely dangerous situations may be overlooked!

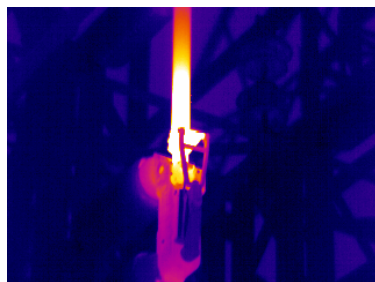
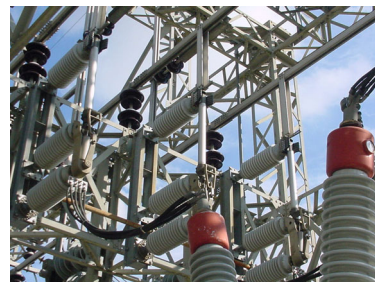
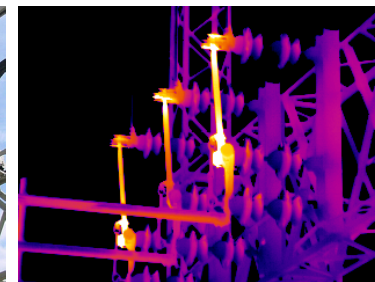
Figures 2a-2c: 69KV Air Break Switches. Anomalies within the contacts and mechanism.

A quick scan of the high voltage structure easily detects this type of problems.

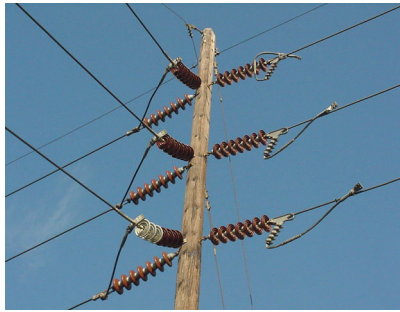
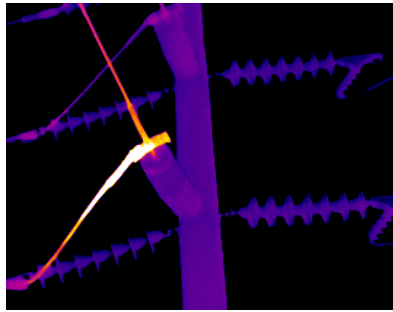
Figures 3a-3b: 69KV Line Connections supporting substation

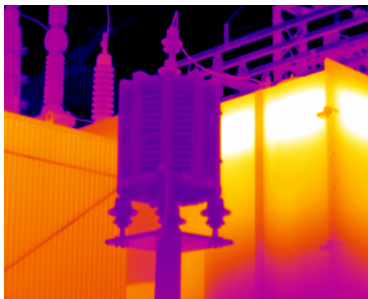
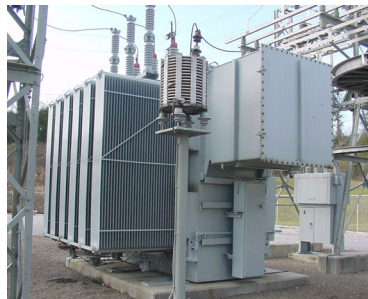
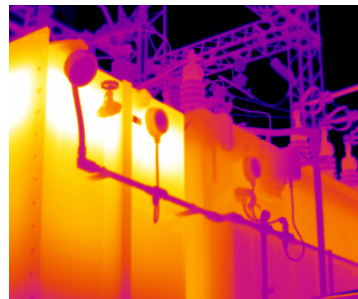
Figures 4a-4c: 25MVA Transformer

Thermal levels in tapchanger compartments should never be higher than winding compartments. The images above indicate a critical condition within this tapchanger!

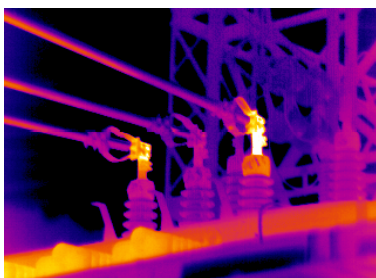
All three images above show conditions thermographers may encounter. Figure 5a shows connection problems on secondary bushings. Figure 5b indicates a secondary core ground that allows iron of the winding structure to become a current path. Figure 5c shows malfunctioning radiators. All three conditions may cause premature unit deterioration.

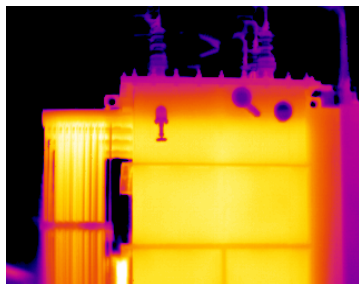
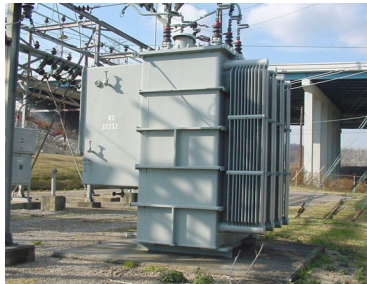
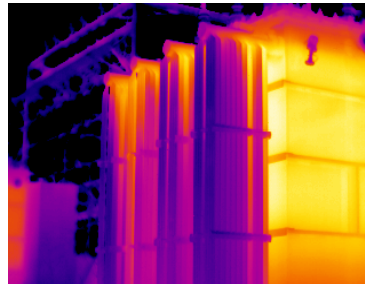
Figures 6a-6c: 25MVA Regulating Transformer

When evaluating transformers and regulators, scan from different angles. From Figure 6a, one might assume this regulator has an adequate oil level for proper radiator function. Figure 6c indicates differently!

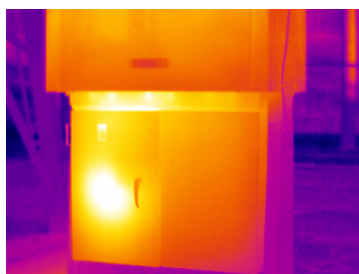
Figure 7a

Not all elevated readings indicate abnormal situations. An inspector might think an internal control wiring problem exists in the breaker shown in Figure 7a, but that is not the case. In fact, that image is normal. The control cabinets of outdoor switchgear are heated. The heater of the circuit breaker in Figure 7c is inoperative, and in danger of moisture encroachment, one of leading causes of switchgear failure.

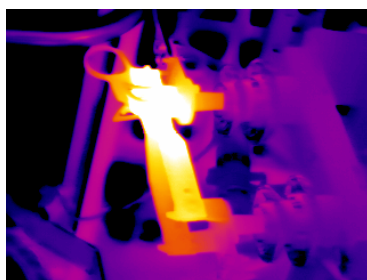
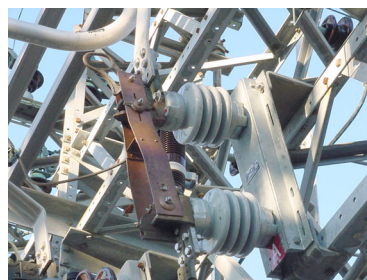
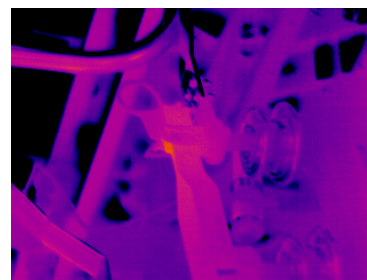
Figures 8a-8c: 15 KV Disconnect Switches: Before & After Replacement

The problem most frequently encountered will be overheated disconnect switches. Usually, only cleaning, adjustment and lubrication are necessary to eliminate that condition, but not always! When extreme cases are documented, it is important to re-evaluate after maintenance is performed. If the condition persists, replacement may be required.

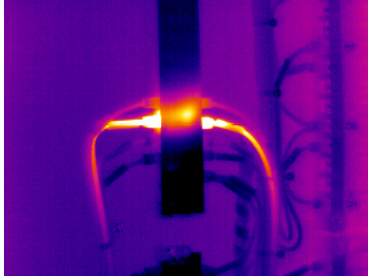
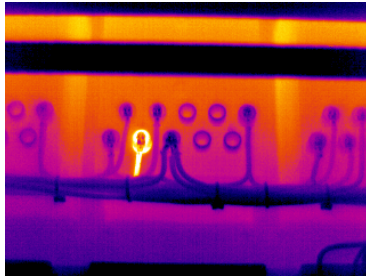
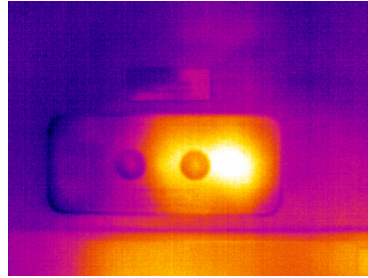
Figures 9a-9c: Common Control System Problems

Often, tightening a terminal screw is all that is needed. Even if this is the case, allow time for cooling to ensure that the problem is resolved. Other conditions that may cause this abnormal thermal signature include improperly pressed crimp connections, broken terminal screws, and deteriorated control wire. The problem source must be positively identified and eliminated, or system protection may be jeopardized.

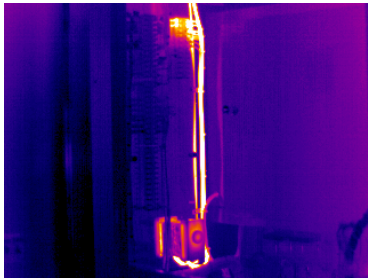
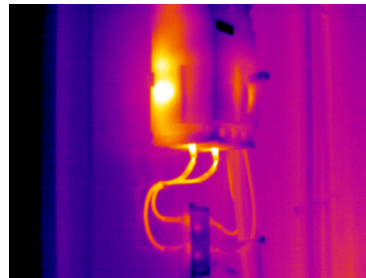
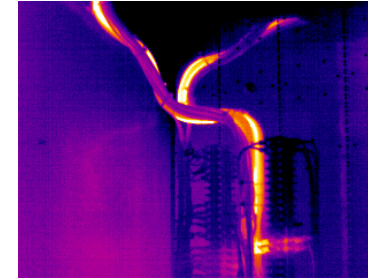
Figures 10a-10c: Overloaded Circuits

Inspect all control wiring for overloaded circuits. Undersized wire or excessive current levels can cause this condition. In either case, this condition poses an extremely dangerous situation. Control system failure can have catastrophic consequences!
