Infrared inspections of electric substations: the importance of developing a Plan

James Dan Roark, Knoxville Utilities Board (KUB), Knoxville, Tennessee

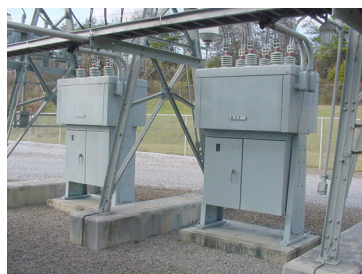
Figure 7b

Figures 7a-7c: 14.4KV Vacuum Circuit Breakers

Not all elevated readings indicate abnormal situations. An inspector might think an internal control wiring problem exists in the breaker shown in Figure 7a, but that is not the case. In fact, that image is normal. The control cabinets of outdoor switchgear are heated. The heater of the circuit breaker in Figure 7c is inoperative, and in danger of moisture encroachment, one of leading causes of switchgear failure.
